Alert Service Bulletin B787-81205-SB320045-00 LANDING GEAR - Main Landing Gear - Truck Beam and Inner Cylinder Pivot Joint Inspection and Lubrication

Publication:	B787-81205-SB320045-00	Issue 001, 09 Nov 2020
--------------	------------------------	------------------------

787-8, 787-9, 787-10 Airplanes. Refer to Data Module SB B787-A-32-00-0045-00A-932A-D, Paragraph 1., Effectivity for the list of affected airplanes.

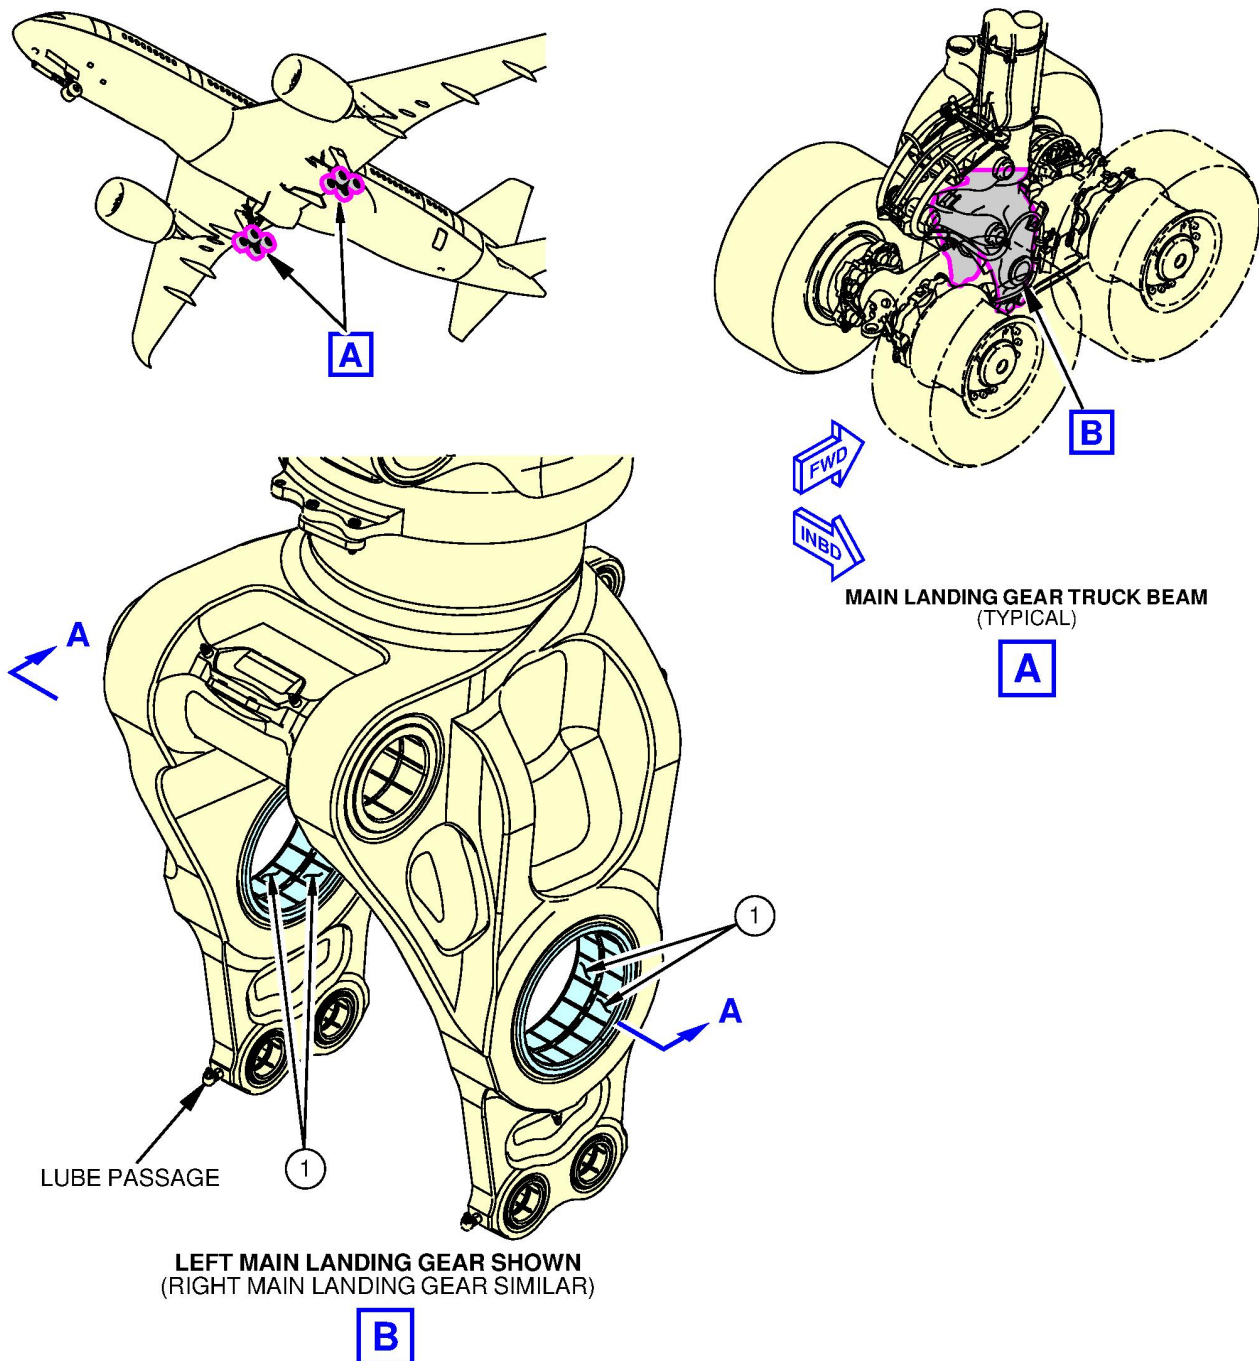
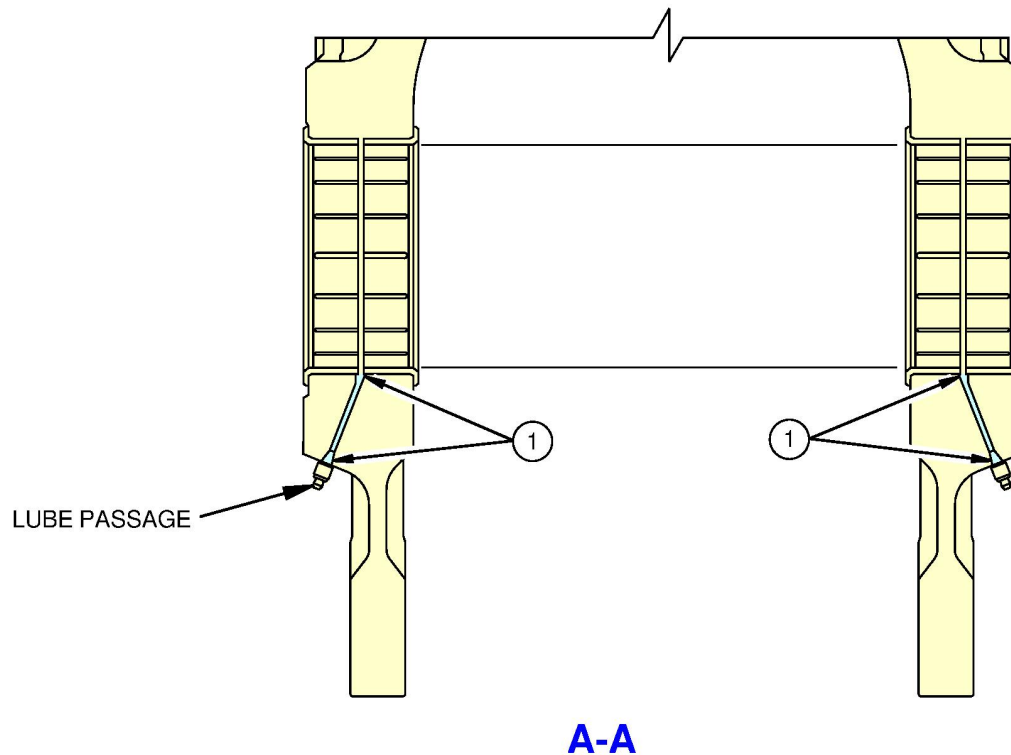
Figure 1 LEFT AND RIGHT MLG TRUCK BEAM AND INNER CYLINDER PIVOT JOINT - INNER CYLINDER BUSHING INSPECTION

Condition	Action	Compliance Time (Whichever Occurs Later)		Repeat Interval (Not to Exceed)
All Airplanes	Do a detailed inspection of both the left and right MLG inner cylinder bushing inner diameter (ID) surface for excessive wear, cracks and smearing of bushing material	Within 24 months after the Issue 001 date of the Requirements Bulletin B787-81205-SB320045-00 RB	Within 36 months after the date of issuance of the original standard certificate of airworthiness or the original export certificate of airworthiness	-
CONDITION 1: NO INNER CYLINDER BUSHING ID EXCESSIVE WEAR, NO CRACK AND NO SMEARING FOUND	ACTION 1: Apply lubrication using MIL-PRF-32014 grease and make sure lubrication passages are clear	Before further flight		-
	ACTION 2: Repeat the detailed inspection for both the left and right MLG inner cylinder bushing inner diameter (ID) surface for excessive wear, cracks and smearing of bushing material	-		36 Months *[1]

CONDITION 2: ANY INNER CYLINDER BUSHING ID EXCESSIVE WEAR, CRACK OR ANY SMEARING FOUND	Do a detailed FPI inspection of the inner cylinder lug bore for heat and friction damage	Before further flight		-

Condition	Action	Compliance Time (Whichever Occurs Later)	Repeat Interval (Not to Exceed)
CONDITION 2.1: NO HEAT DAMAGE AND NO FRICTION DAMAGE FOUND ON THE INNER CYLINDER LUG BORE	ACTION 1 (OPTION 1): Install new Aluminum-Nickel-Bronze Inner Cylinder Bushing(s)	Before further flight	*[1]*[2]
	ACTION 1 (OPTION 2): Install new Copper-Nickel-Tin Inner Cylinder Bushing(s) *[1]*[2]	Before further flight	-
	OPTION 1 and OPTION 2 (ACTION 2): Apply lubrication using MIL-PRF-32014 grease and make sure lubrication passages are clear	Before further flight	-
	OPTION 1 AND OPTION 2 (ACTION 3): Repeat the detailed inspection for both the left and right MLG inner cylinder bushing ID surface for excessive wear, cracks and smearing of bushing material	-	36 Months *[1]
CONDITION 2.2: ANY HEAT DAMAGE OR ANY FRICTION DAMAGE IS FOUND ON THE INNER CYLINDER LUG BORE	Contact Boeing for repair instructions and do the repairs.	Before further flight	-

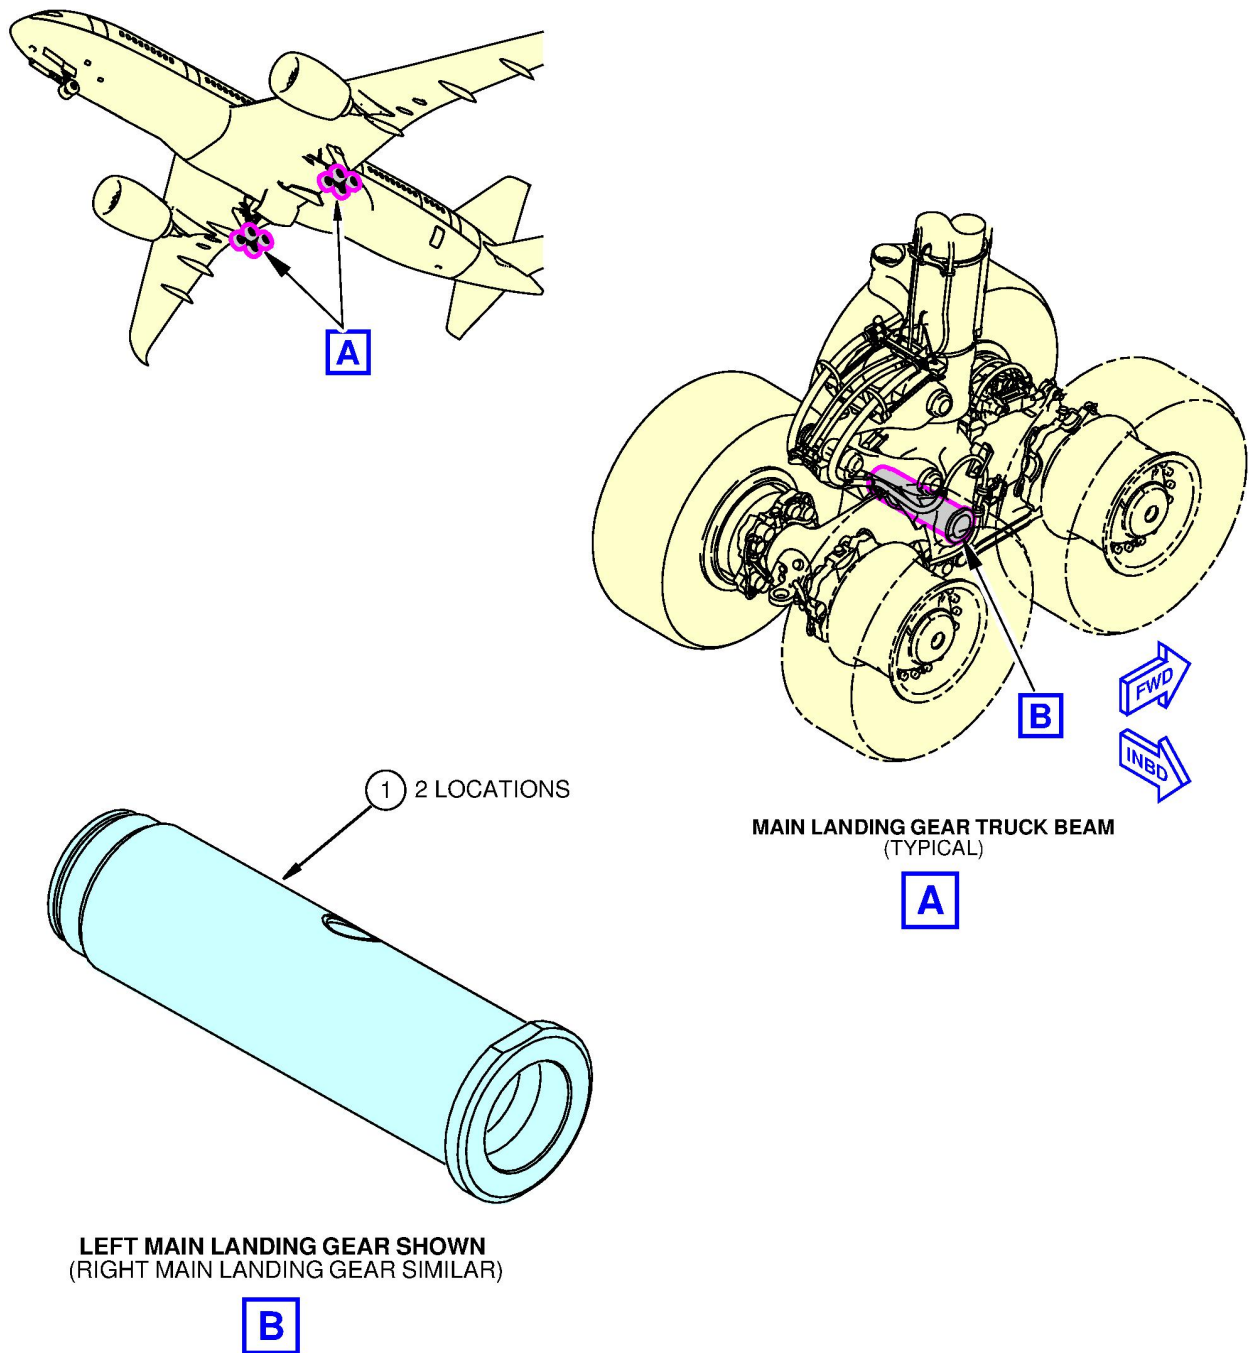
LEFT AND RIGHT MLG TRUCK BEAM AND INNER CYLINDER PIVOT JOINT - PIVOT PIN INSPECTION

Fleet sampling inspection of some airplanes found cracks in the left and right MLG Pivot Pins on one of the airplanes. The pins exhibited cracking of the High Velocity Oxygen Fuel (HVOF) tungsten carbide - cobalt - chrome coating. Removal of the outer diameter coating disclosed cracking of the custom 465 CRES substrate. The cause of the cracking was determined to be heat damage due to in-service friction.

8. Heat damage is defined as ladder cracks, spalling, pull-outs, cracks, chips, flakes, lifting, or color changes.
9. Friction damage is defined as material transfer on the part surface or other contaminants found.
